# Flood Investigation Report

Devon Floods 21<sup>st</sup> – 25<sup>th</sup> November 2012

Final Report

This flood investigation report has been produced by Devon County Council as a Lead Local Flood Authority under Section 19 of the Flood and Water Management Act 2010

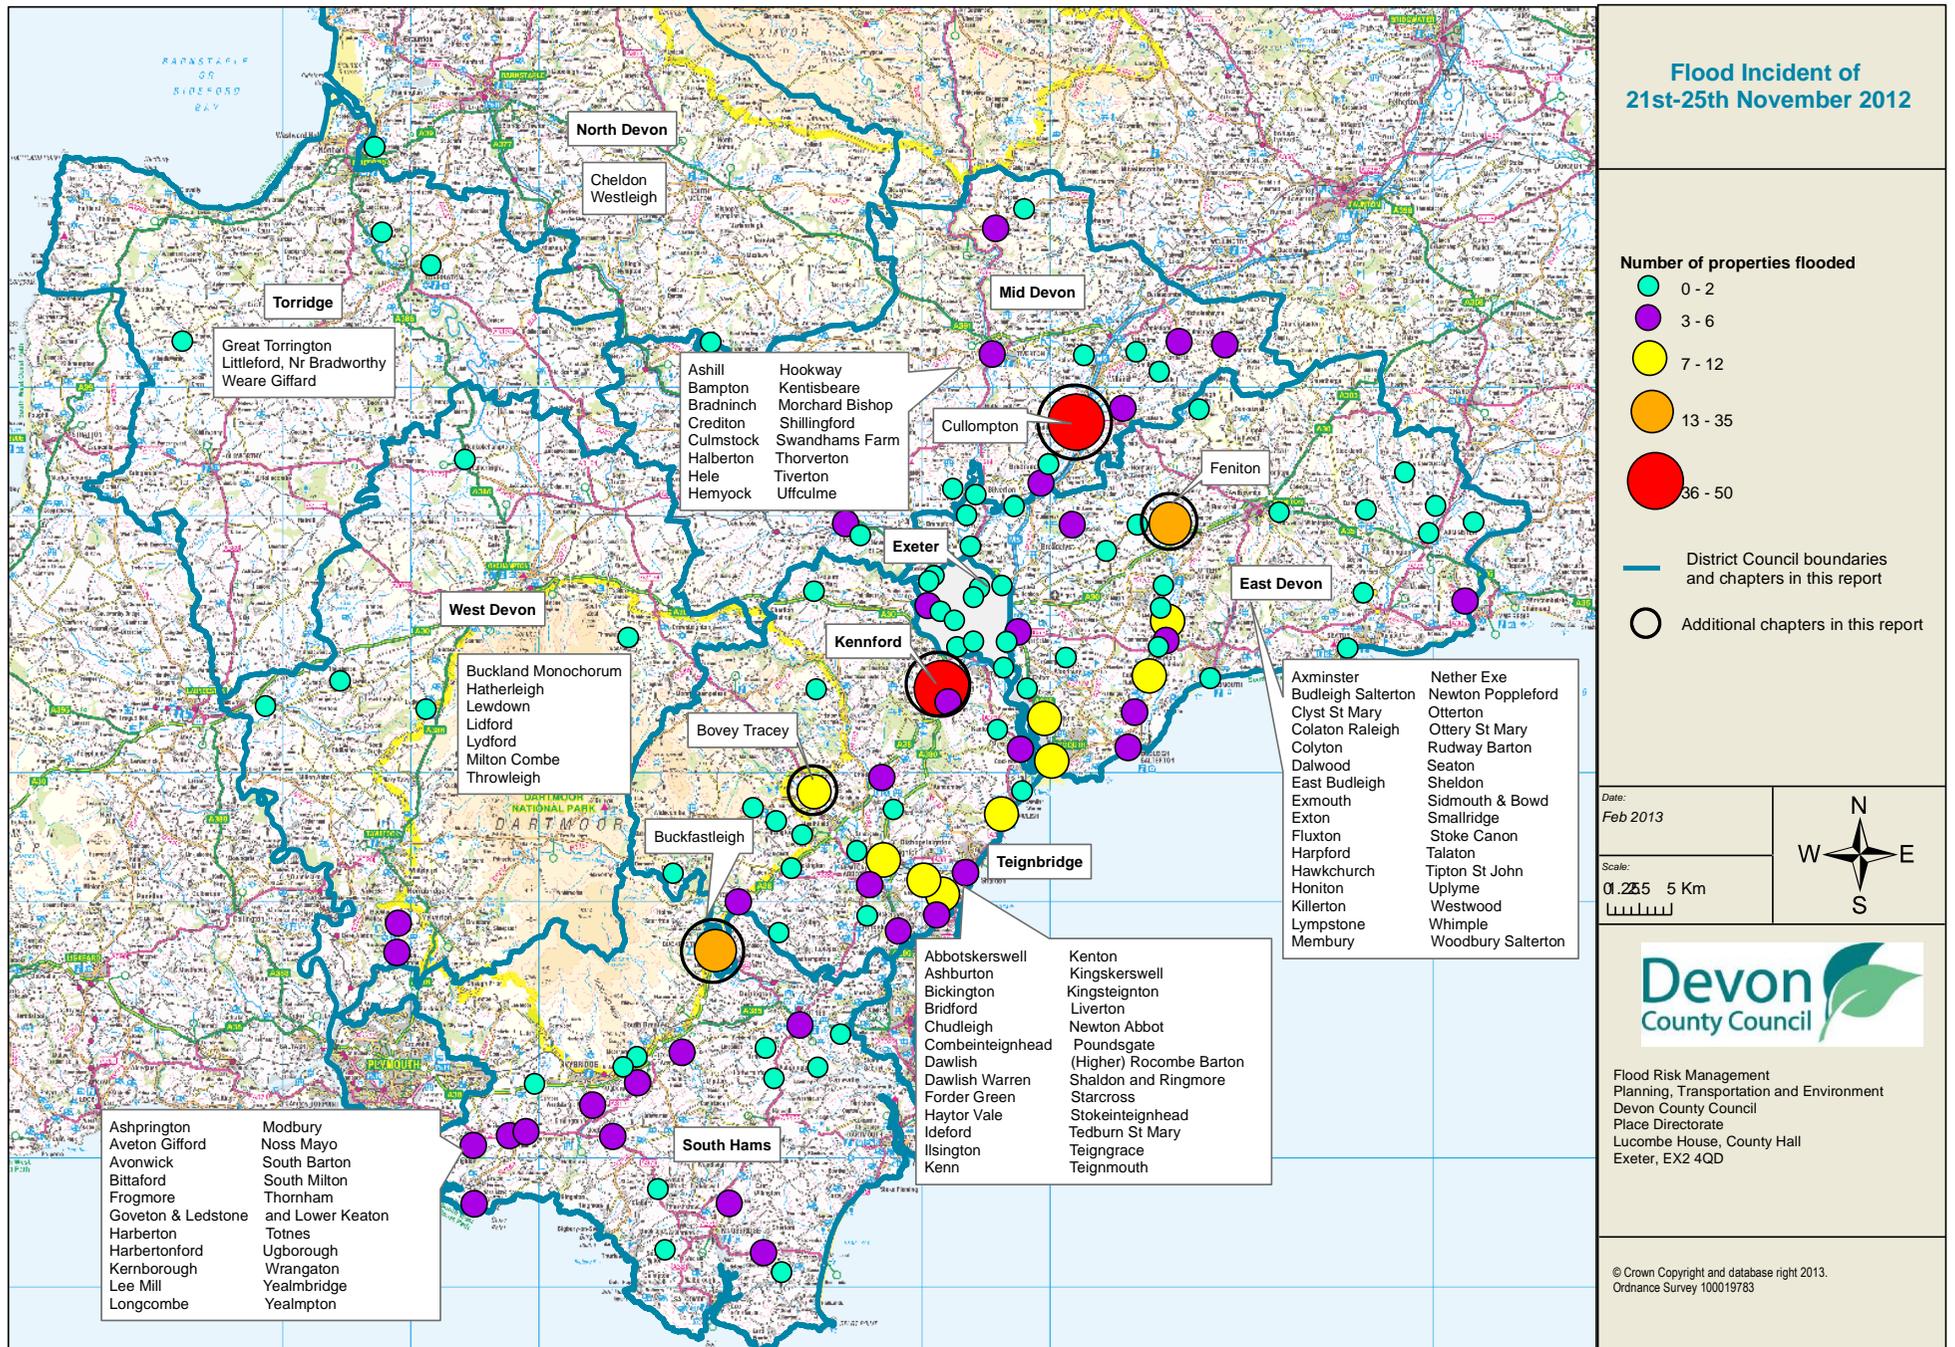
Figure 3.1. The extent of flooding across Devon over 21<sup>st</sup> – 25<sup>th</sup> November and how these have been grouped together as chapters in this report.

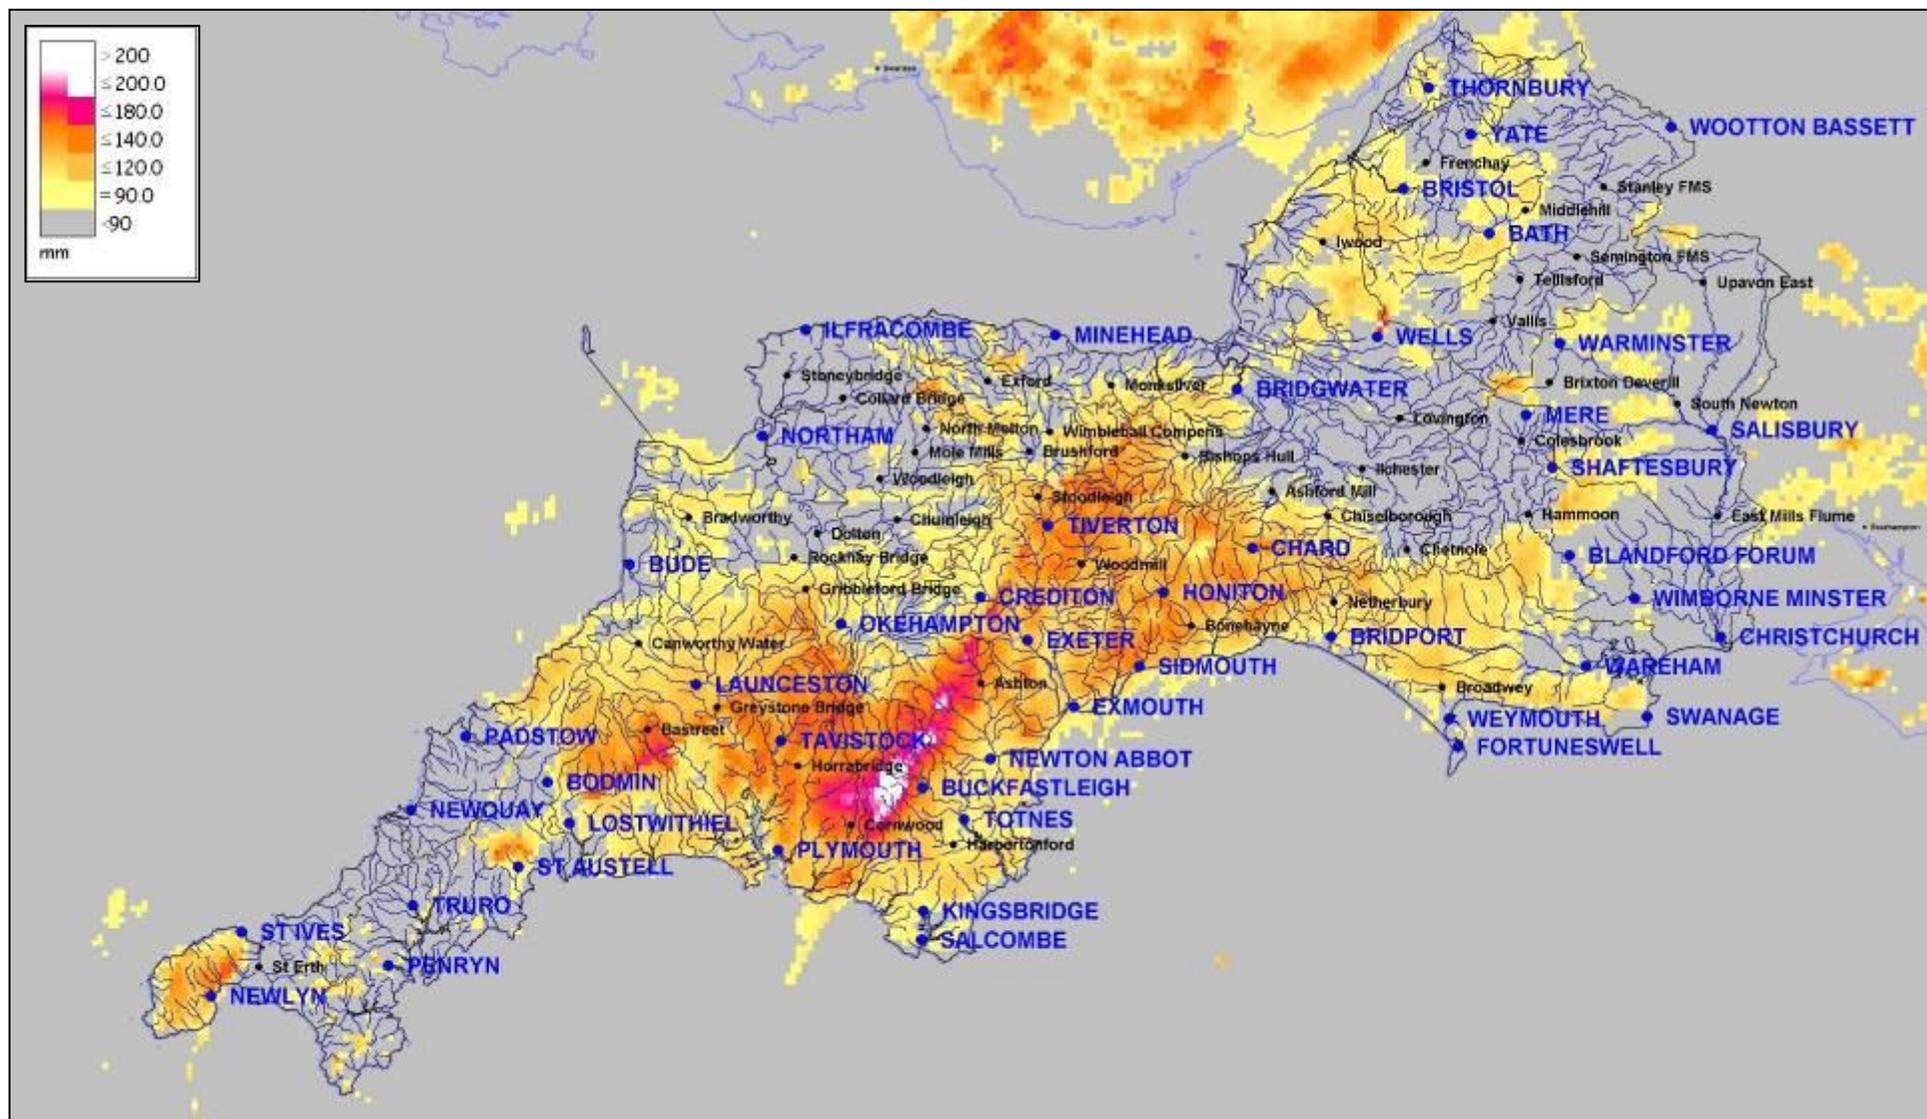
In the six days leading up to the event up to 250mm of rainfall was recorded with up to 85mm of that in the last 24 hour period. In 2000 we had up to 270mm in 10 days and 90mm in 30 hours, so very similar in rainfall terms. Figure 3.2 shows the rainfall radar image during the storm. In many places, the highway drainage systems were overwhelmed. This is unsurprising as they are not designed to cope with such extreme flood conditions that were experienced during this event.

Figure 3.2. Radar image showing the UKPP total rainfall accumulations per 1km (mm) from 04:00 GMT 19-Nov-12 to 04:00 GMT 25-Nov-12.

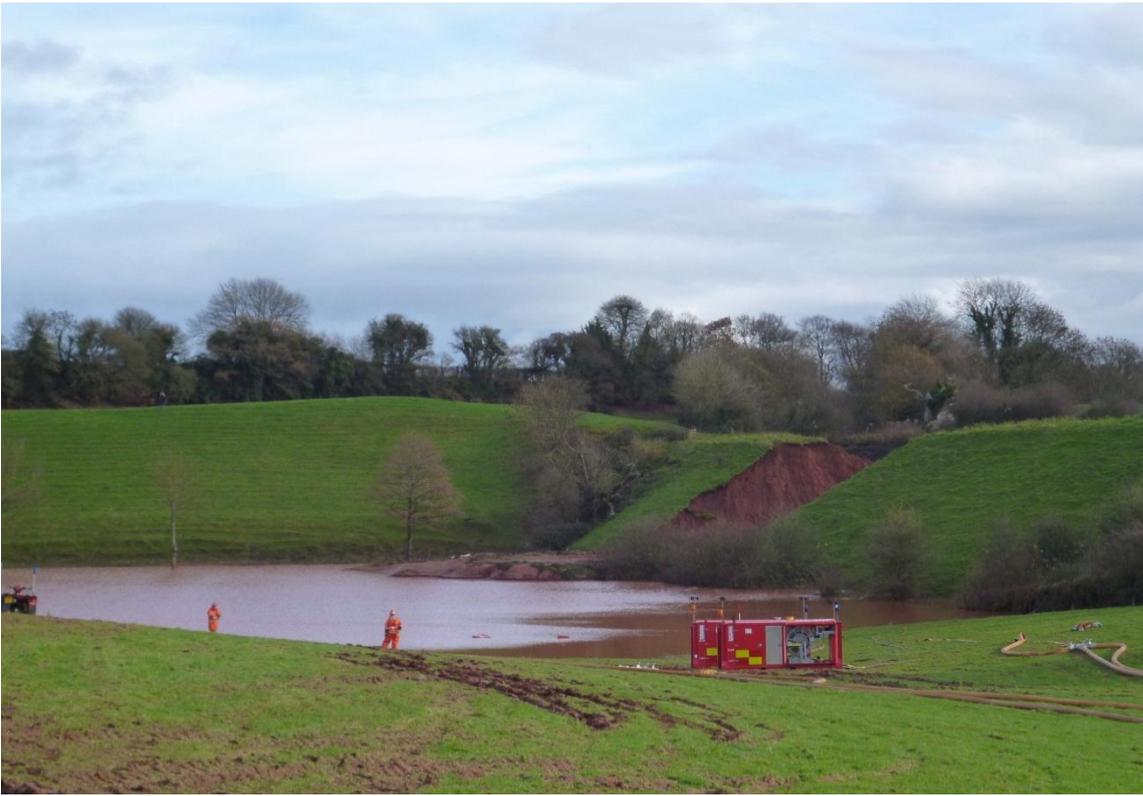
The Devon County Council owned Grand Western Canal suffered a serious breach on 21<sup>st</sup> November 2012 at the Swing embankment which rises nearly 60 feet from surrounding fields at Halberton. The breach was a result of erosion resulting from over-topping of the embankment, rather than an inherent failure of the embankment. This followed unprecedented rainfall of 38mm during the early hours (as recorded at a nearby weather station), coupled with the ingress of water into the canal from adjoining land.

**Figure 4.1.** Fire Service pumping water from the lagoon formed by the canal breach.

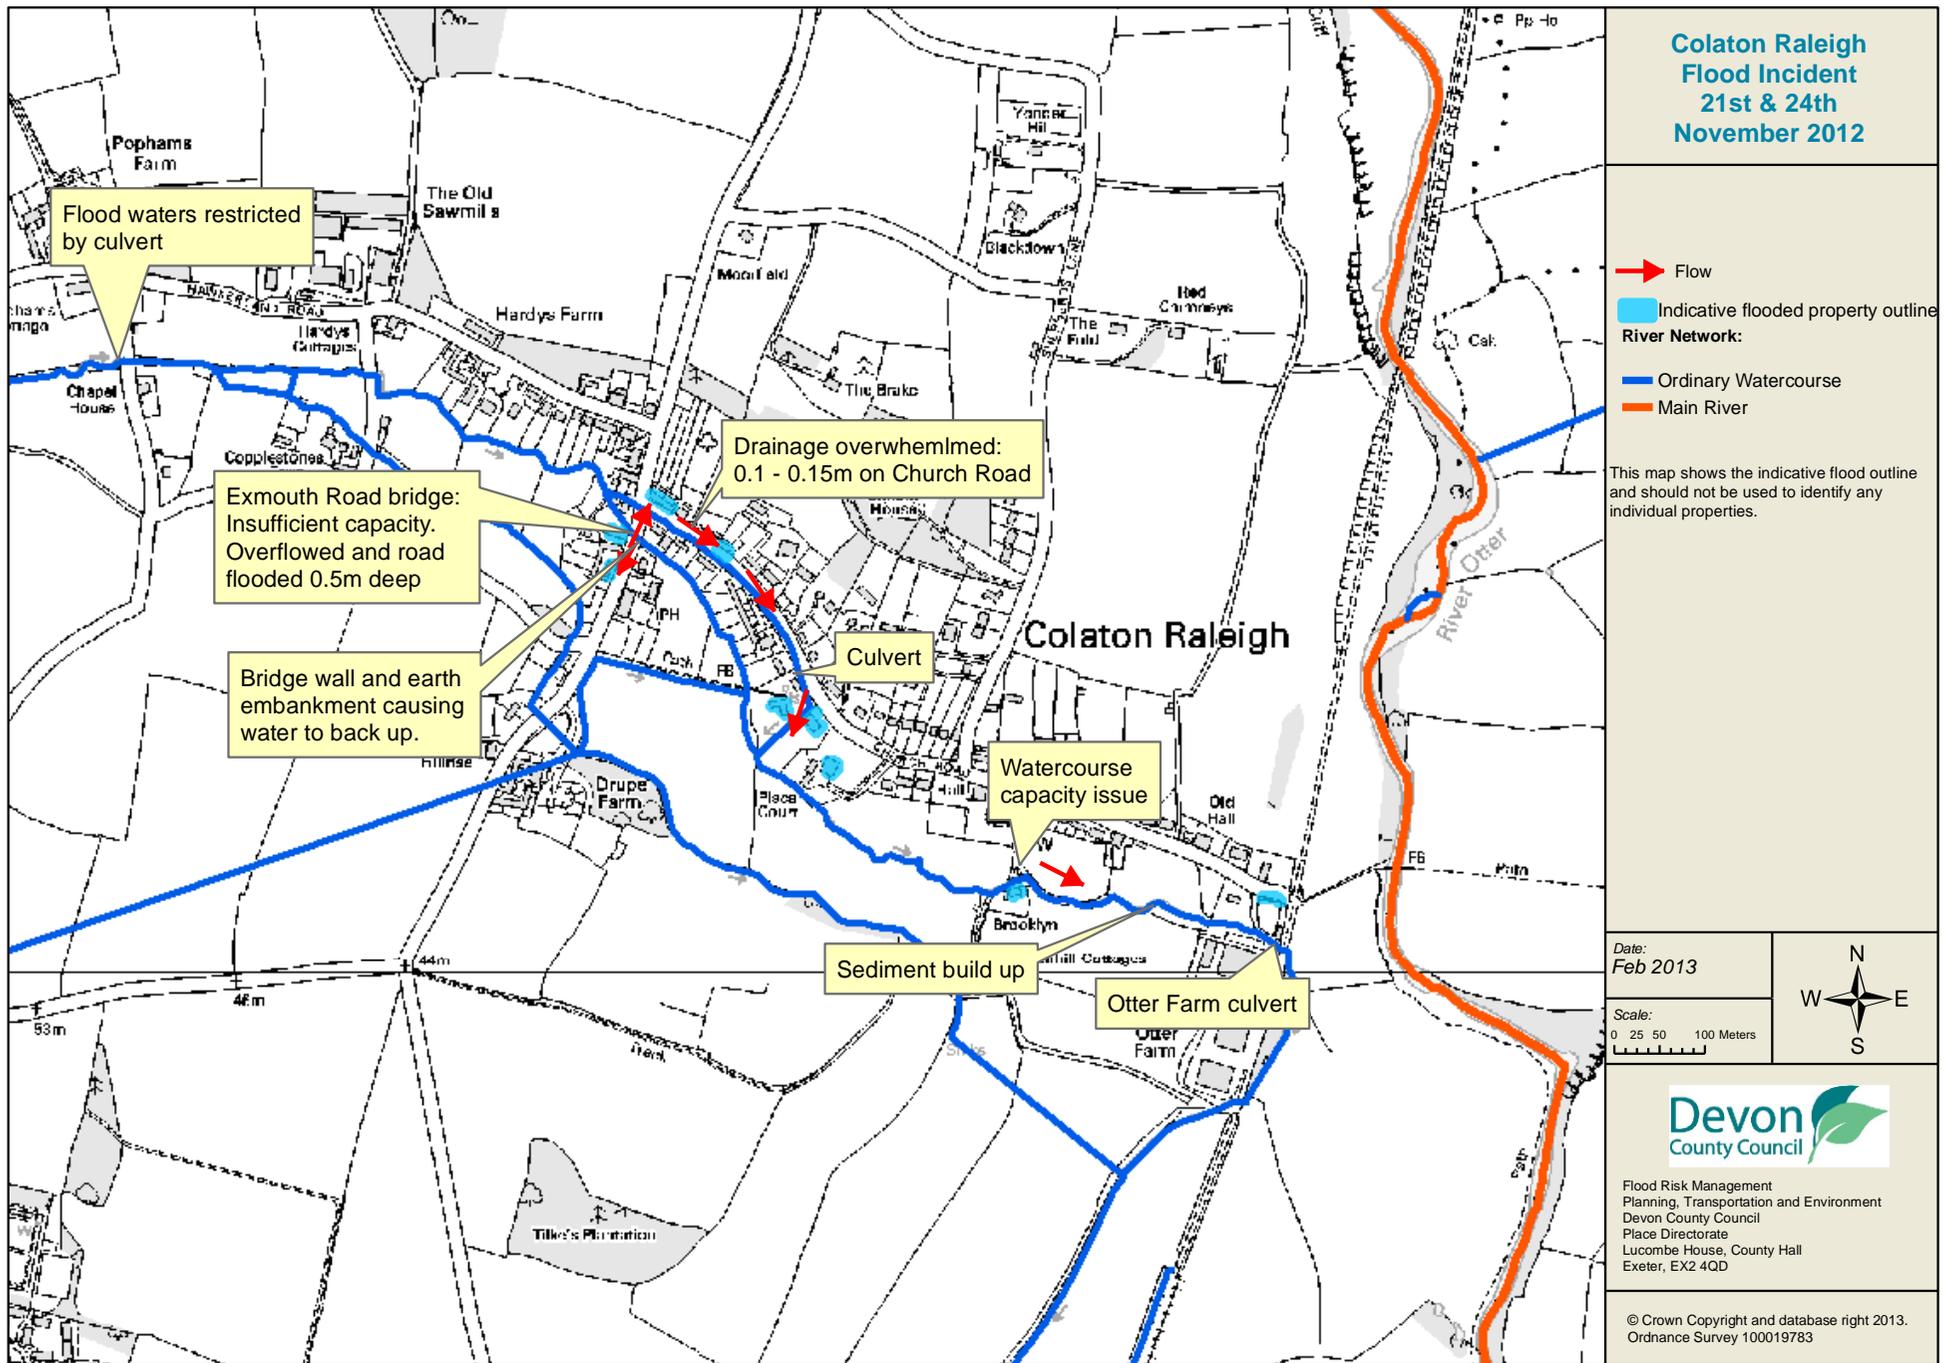
Figure 5.1. November flood extent and impact in Colaton Raleigh

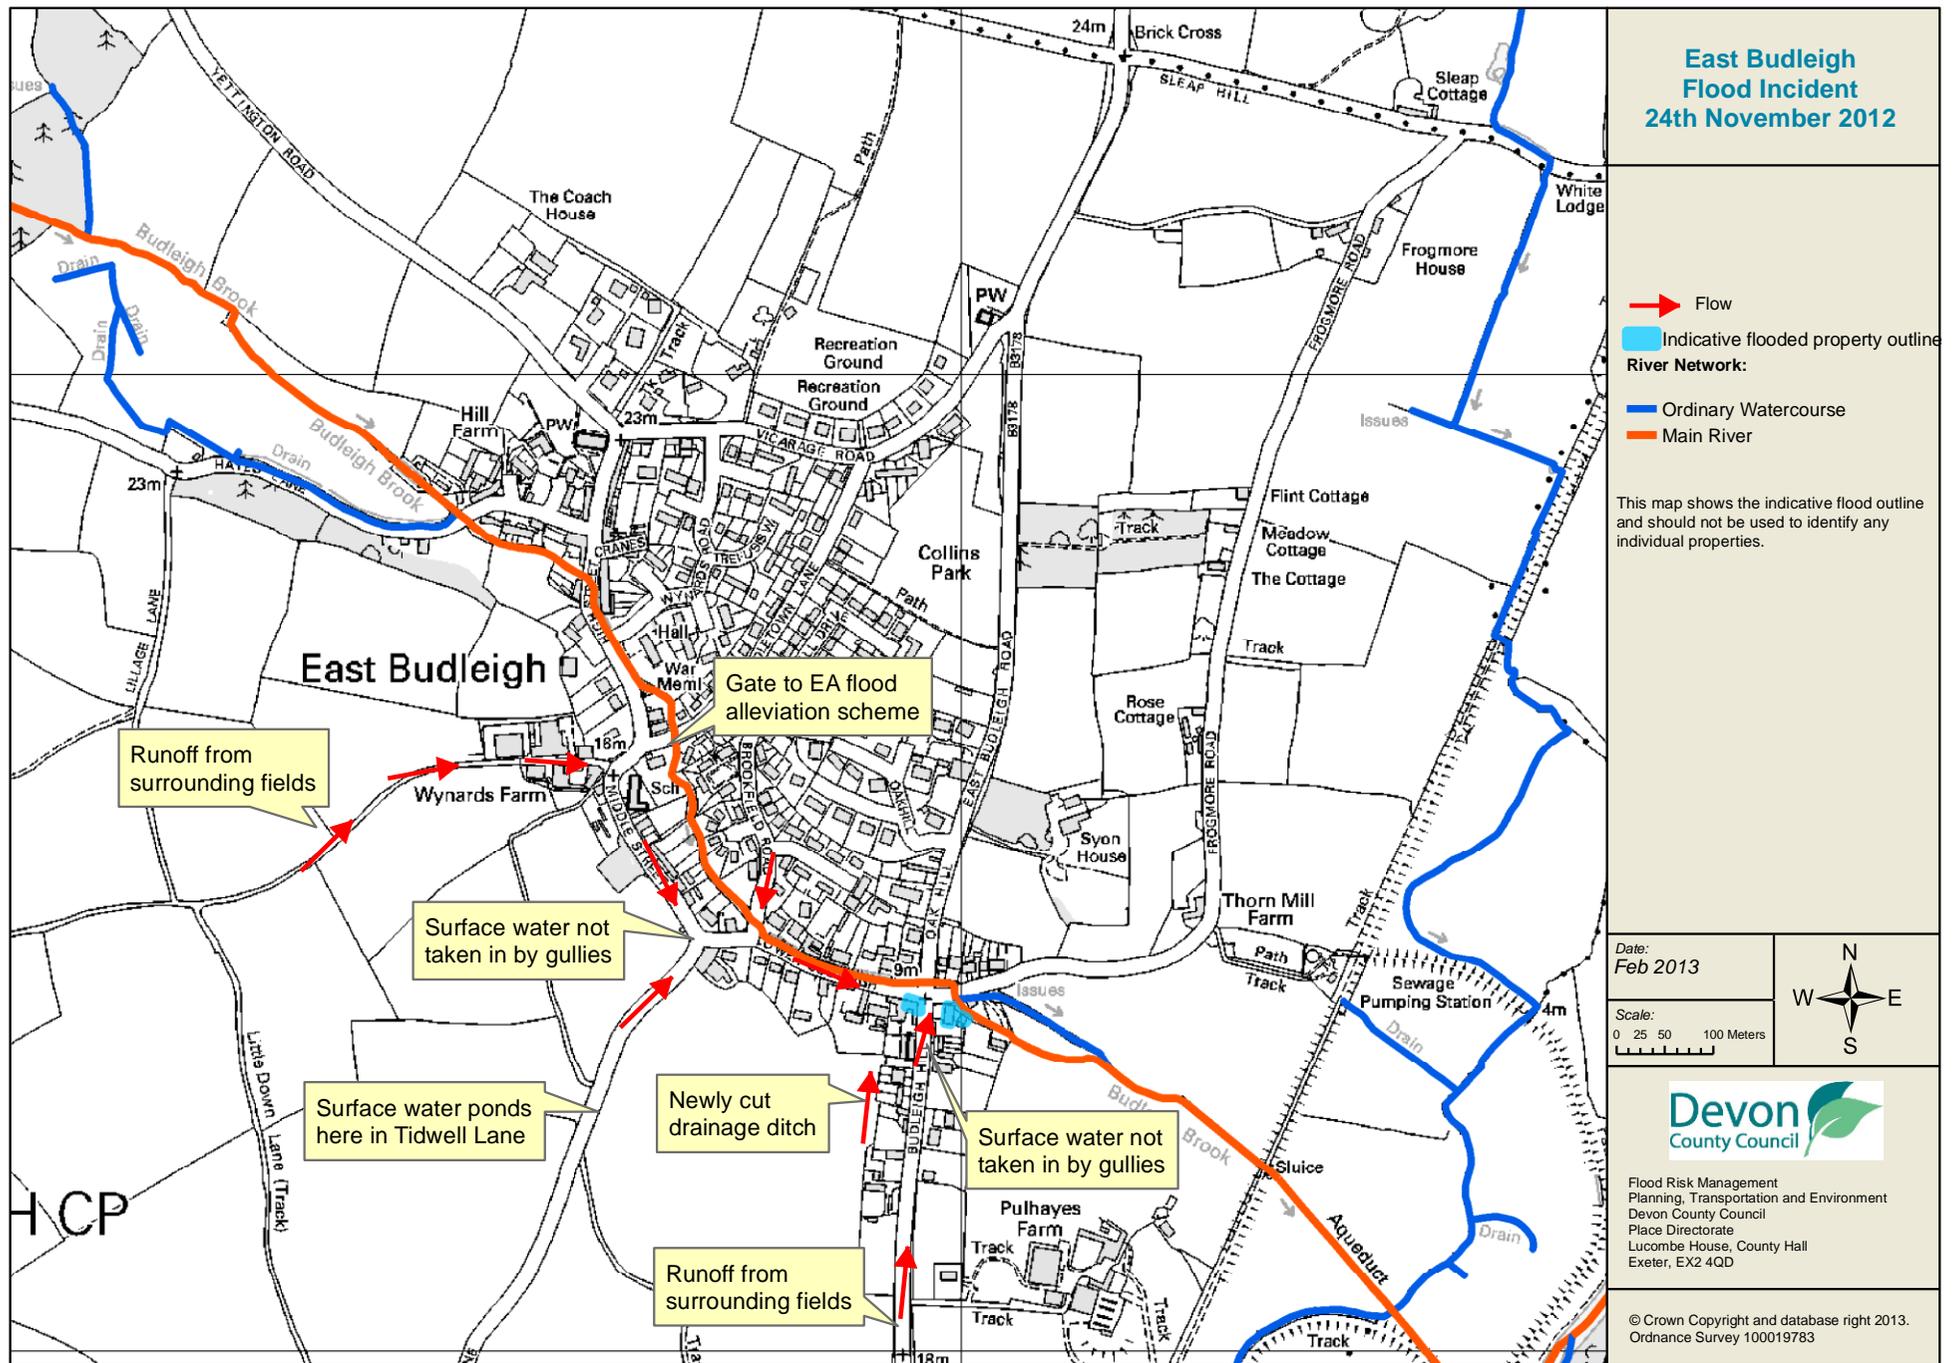
Following the flooding in East Budleigh on 24<sup>th</sup> November 2012, Environment Agency Reconnaissance Teams visited the village. Evidence was found of the East Budleigh Brook overtopping in Lower Budleigh and surface water coming down Middle Street and Brookfield Road. Water also came down from Budleigh Hill and joined the East Budleigh Brook flows, contributing to the flooding of 2 properties next to the river. In total, 5 properties were flooded in East Budleigh, including a village pub. Figure 5.2 shows the extent of the flooding.

Figure 5.2. November flood extent and impact in East Budleigh

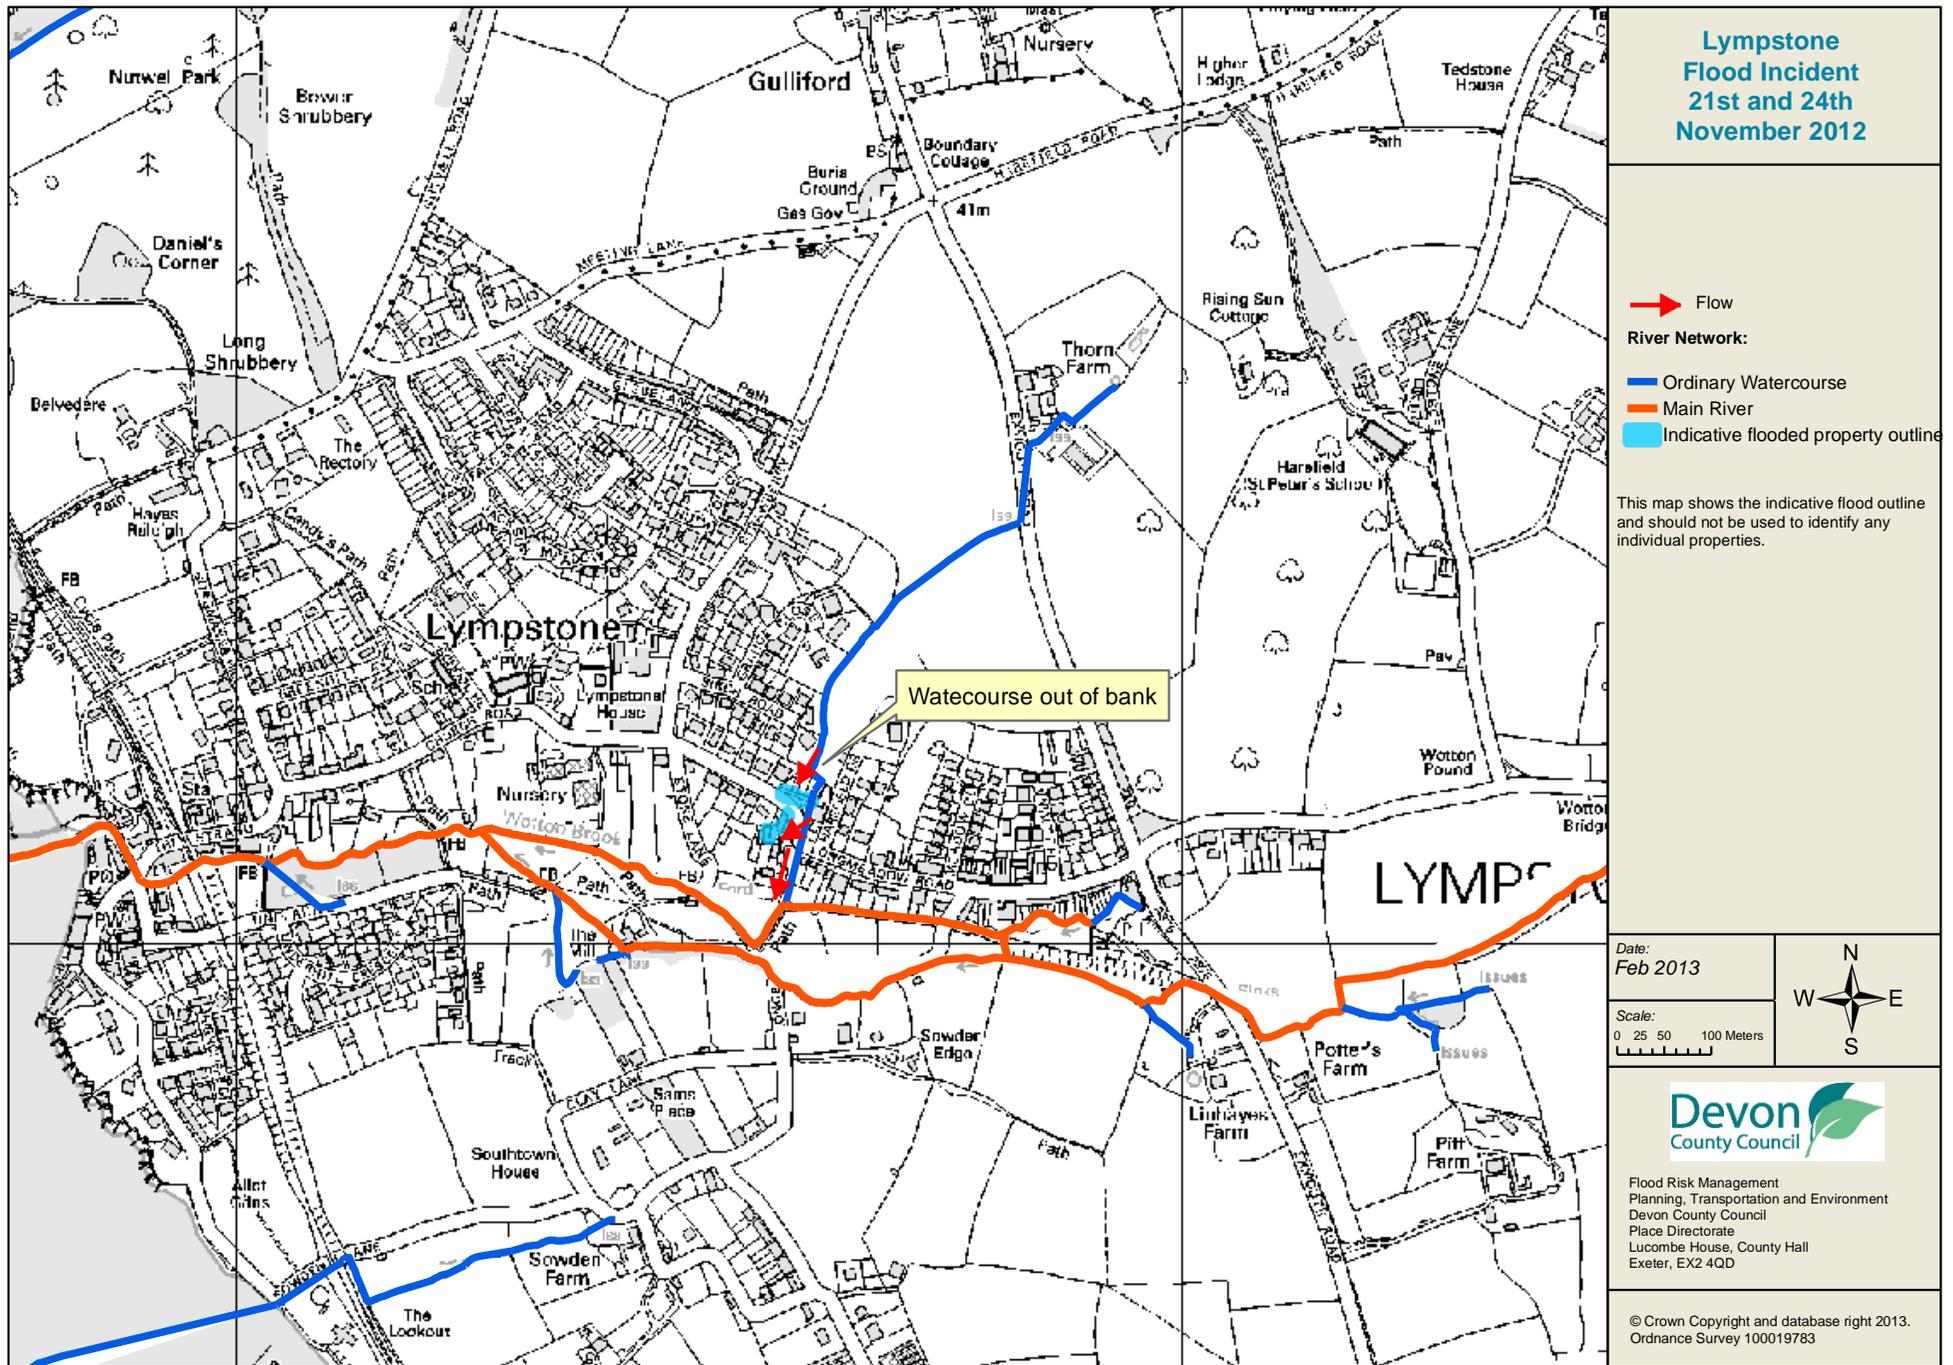
In Lympstone, 11 properties were flooded on Longmeadow Road where an ordinary watercourse flowing from Exmouth Road came out of bank and flooding 10 properties. The water then re-joined the Main River Wotton Brook. Just on the outskirts of Lympstone, a blocked culvert was reported on Wotton Lane, said to be causing flooding to 1 property. Figure 5.3 shows the extent of flooding in the centre of Lympstone.

Figure 5.3. November flood extent and impact in Lymington

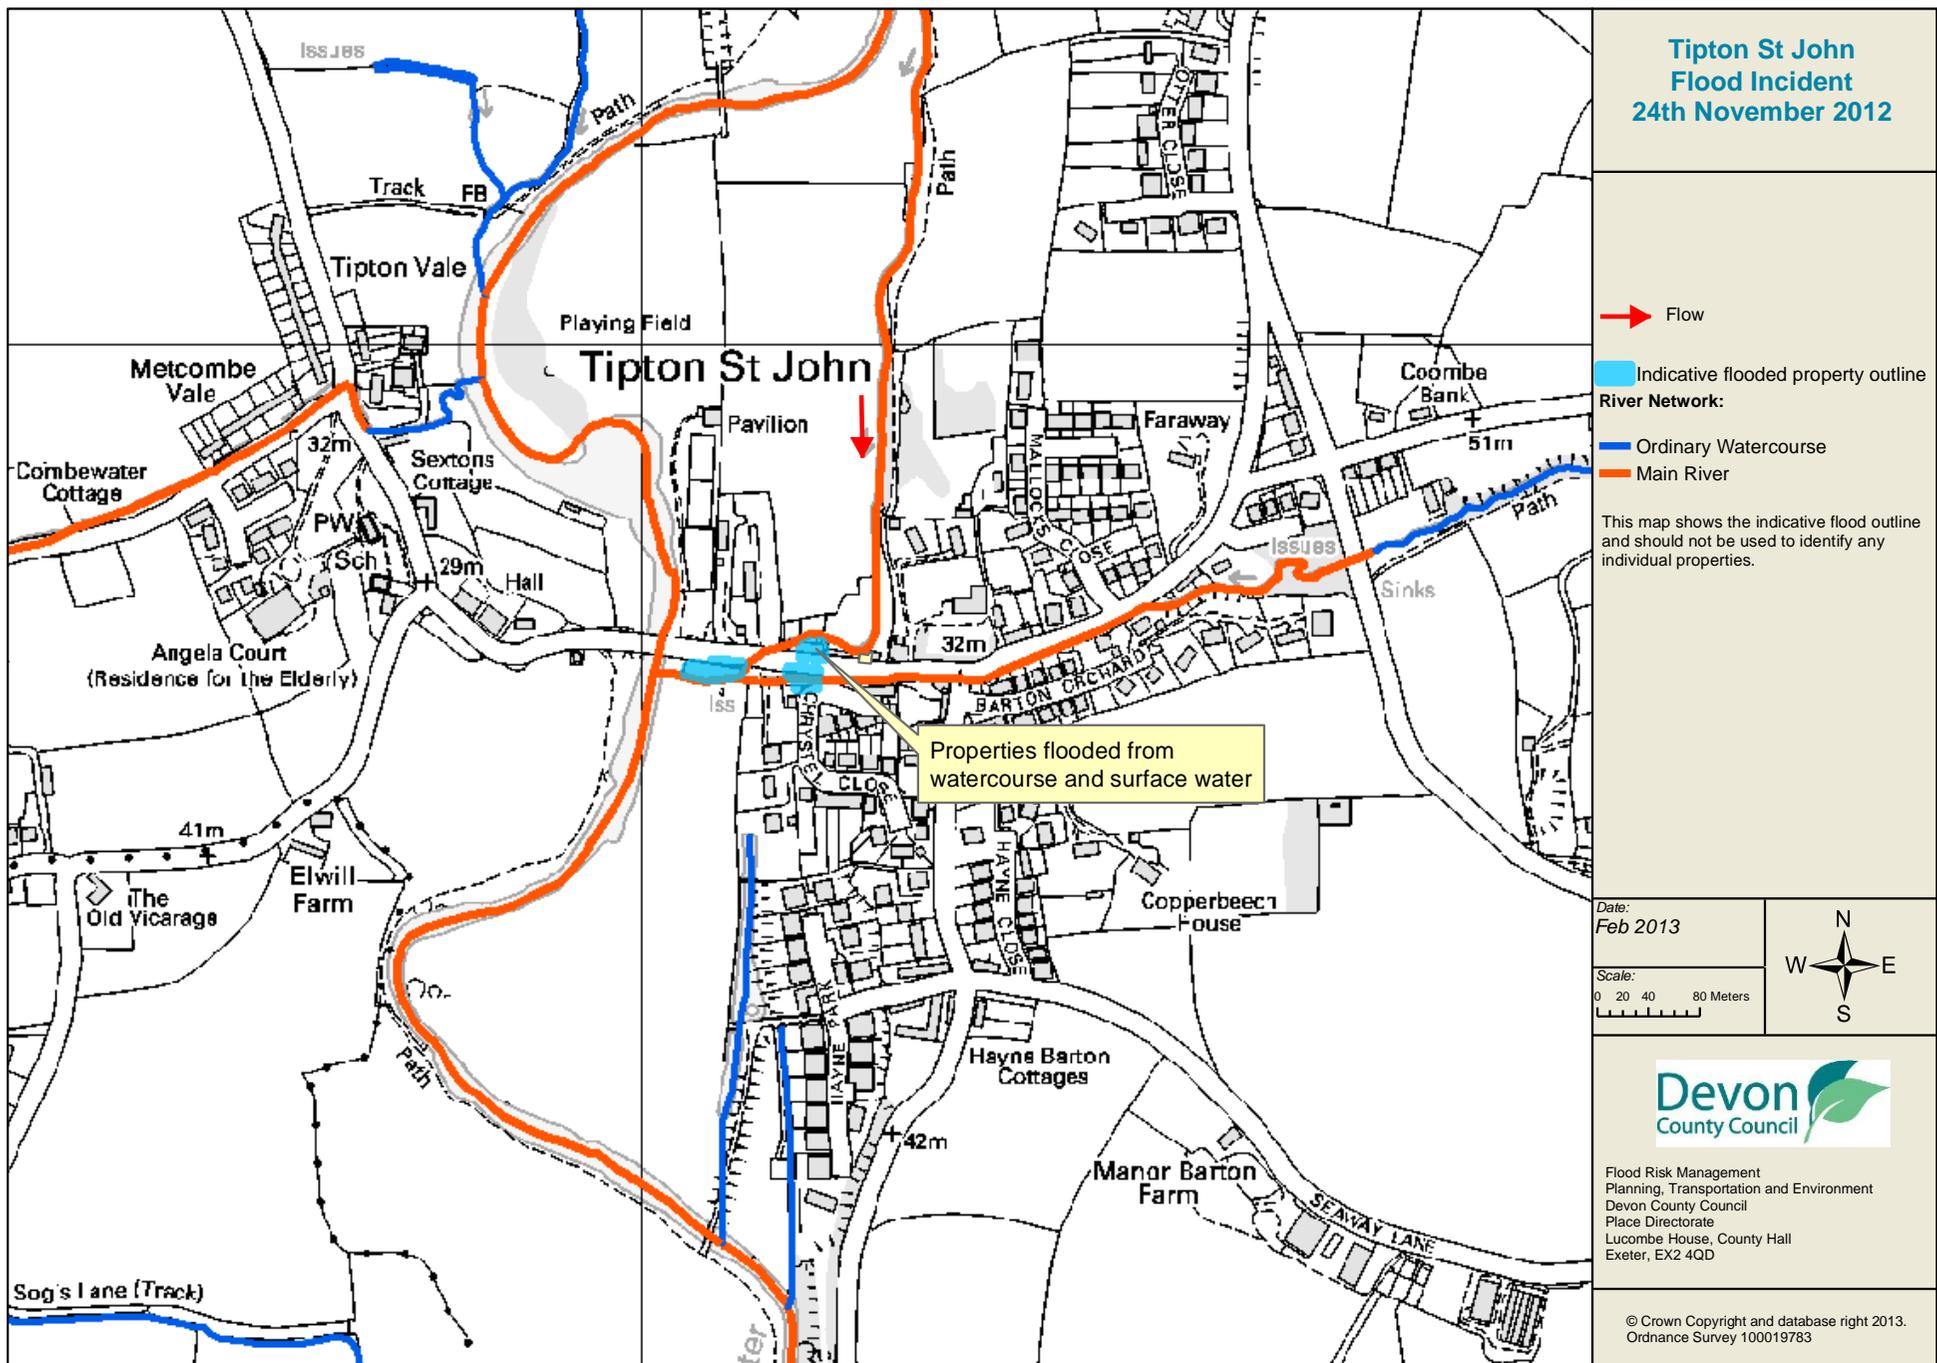
EA reconnaissance records show that the areas flooded in Tipton St John on 24<sup>th</sup> November were along the main road through the village that crosses the River Otter, where the Garage and Pub were both flooded on the South side of the road. On the North side of the road, the Post Office was flooded from the rear and 4 residential properties were flooded from the road. 7 properties in total were flooded from the overtopping of the scheme on the Main River. Figure 5.4 shows the extent of the flooding.

Figure 5.4. November flood extent and impact in Tipton St John

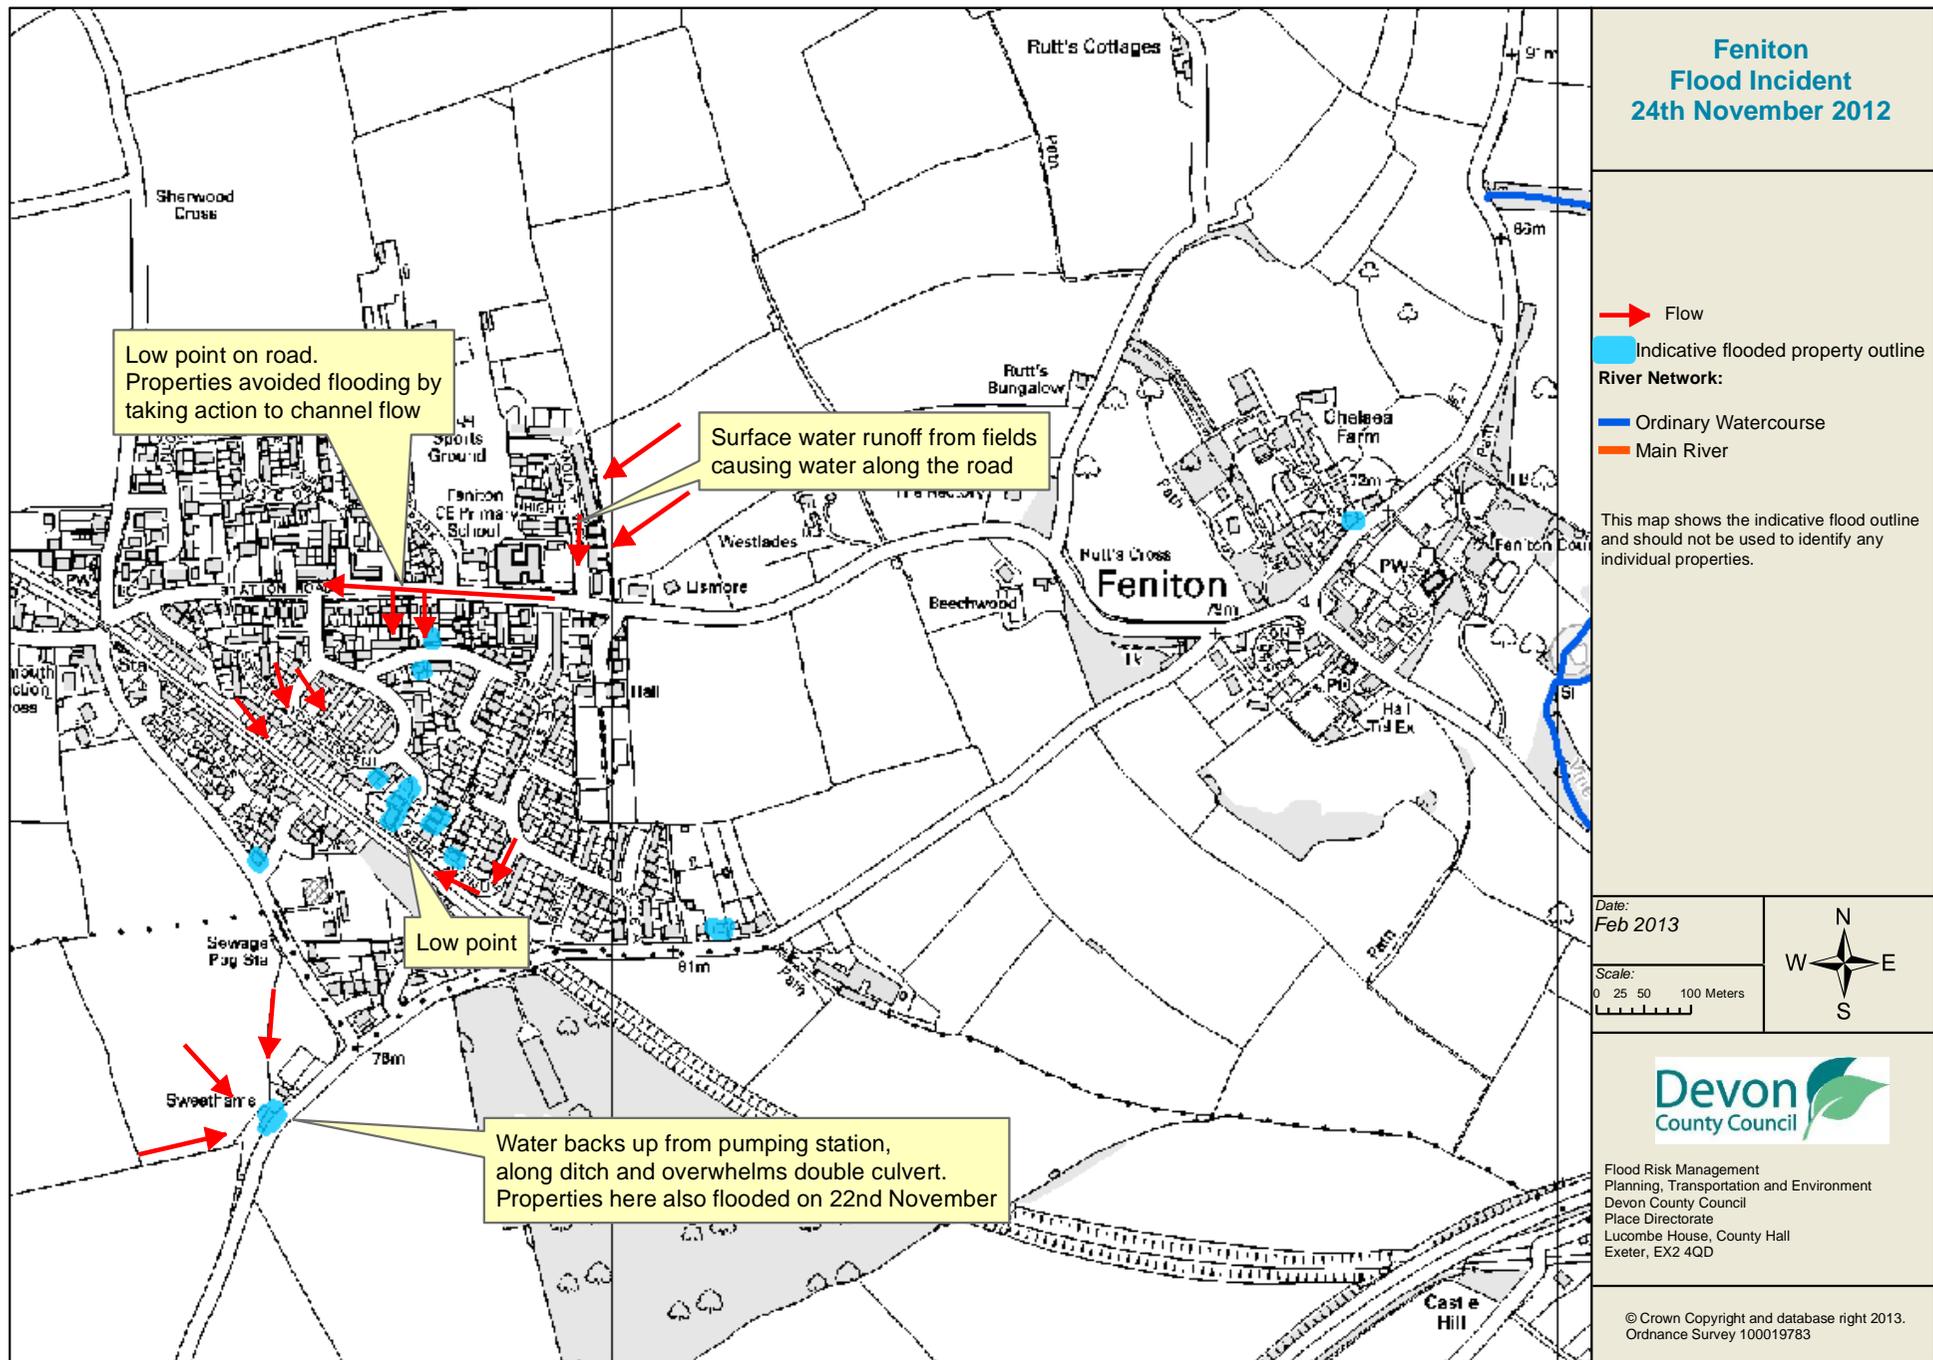
12 properties in total were flooded in the area of Salisbury Avenue, Salisbury Close, York Crescent and Wells Avenue. This was caused by surface water running down York Crescent to the West and along Salisbury Avenue from East to West towards the low point in the road. Other low lying properties in the area narrowly avoided being flooded.

Figure 6.1. November flood extent and impact in Feniton

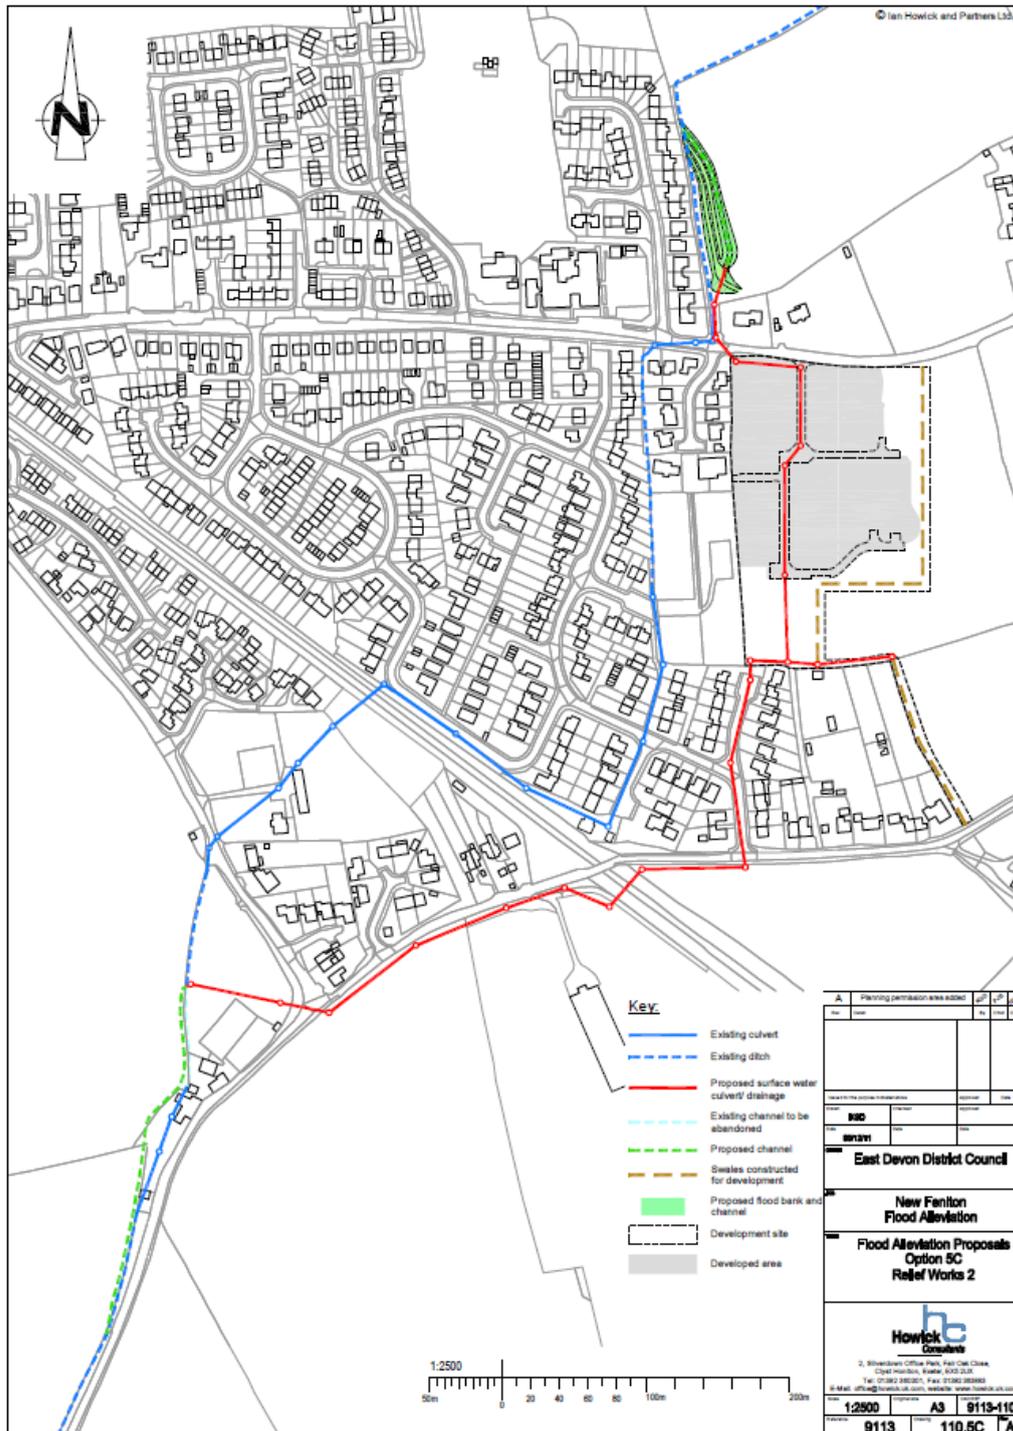
Figure 6.2. Proposed flood alleviation scheme for Feniton.

The total cost of the new flood defence scheme is £1.6m, £500,000 coming from East Devon District Council (EDDC) with the remainder of the funding being sought from DCC, the EA and DEFRA (Department for Environment, Food and Rural Affairs). Figure 6.2 shows a recent plan of the proposed works at Feniton down to, and past Metcombe Cottage. In simple terms EDDC are planning to install a 1050mm diameter pipe on a new line under the railway to connect into the system just above Metcombe Cottage. A new ditch will be formed to bypass Metcombe Cottage and work will have to be carried out downstream to reduce any further risk of flooding at Patteson Cross and the properties all the way down to the Otter. EDDC is working closely with a developer to consider a flood channel and lagoon to control the water travelling down to Patteson Cross.
